Conservation Area Appraisal - **Streatley**

West Berkshire Council Planning and Countryside - August 2010

West Berkshire
COUNCIL

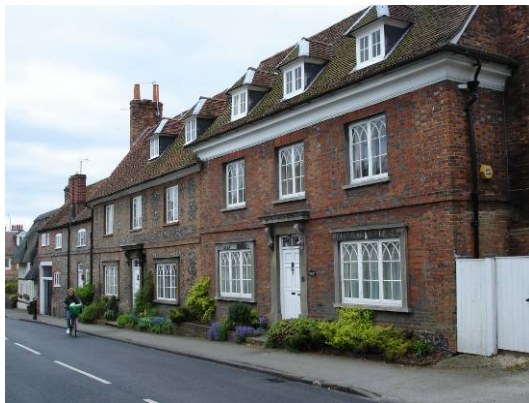
Figure 17: Dormers with hipped tile roofs
Middle House, High Street

- 9.5 Dormers within the conservation area are generally small in scale. In High Street there are examples positioned above eaves level with hipped roofs, leaded hips and four-light casements (as shown at Figure 17). There are examples of gabled eaves dormers in Wallingford Road with brick gables and (typically) two-light leaded casements (see Figure 18).

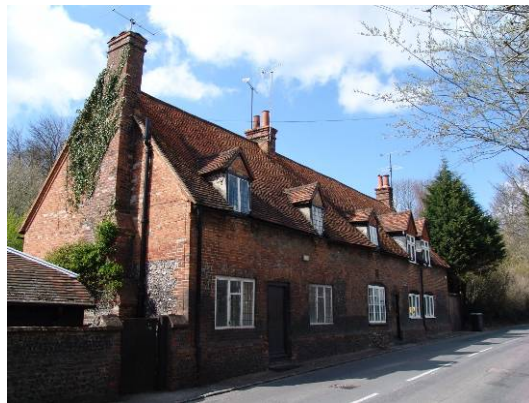
Figure 18: Gabled eaves dormers
Place Manor Cottages, Wallingford Road

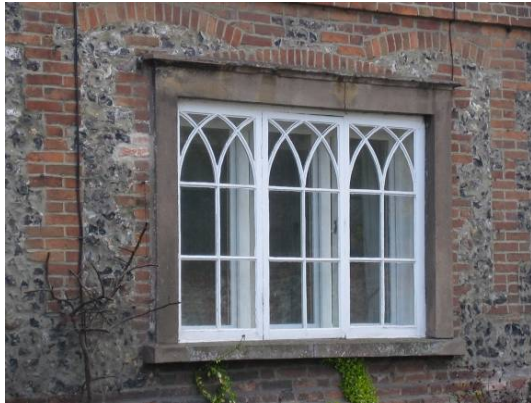
Figure 19: 'Gothick' casements at Middle House

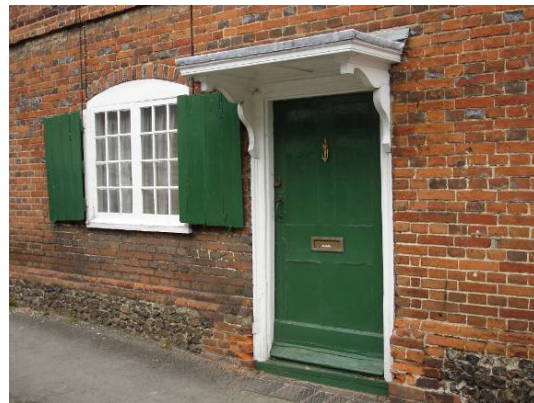
Figure 20: Casement windows, traditional shutters, door and canopy at Bag Row

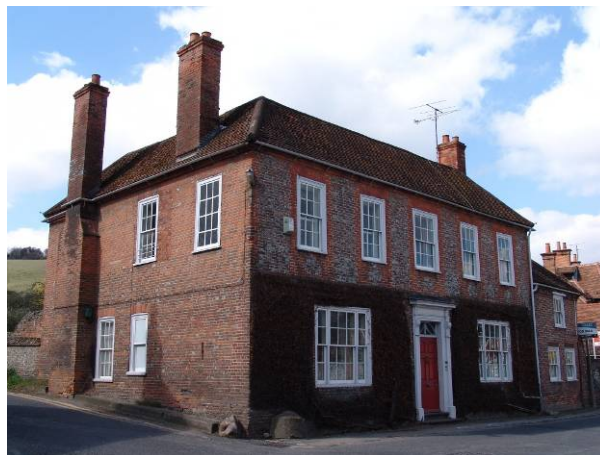
Figure 21: Panels and lozenges of grey bricks at Elm Lodge, Wallingford Road

use of Flemish bond, with grey bricks employed in a variety of patterns including alternating grey headers, panels of grey brick, and lozenges (see Figure 21). The ground floor façade of Childe Court was constructed using grey brick in header bond (shown at Figure 22) which would have been relatively expensive to construct. The use of gauged bright orange-red bricks for flat arched window heads is common in prestigious buildings of the village such as Streatley House. Where buildings have been rendered and/or painted, they have generally been finished in white.

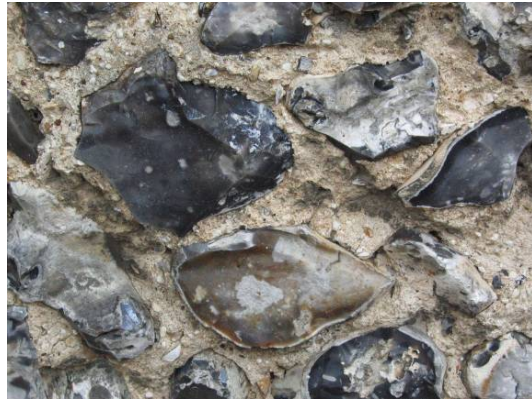
Figure 23: Flint in lime mortar

- 9.9 Another characteristic of the conservation area of Streatley is the use of panels of flint with brick margins and dressings (see Figure 23). This type of construction is most commonly used in the freestanding walls in the village but is also used in a small number of late 17th- and 18th- century houses in the High Street as well as in a number of 19th- century properties.
- 9.10 Lime mortar is used ubiquitously for both brick and flint work in the village. Much original work remains and some sensitive repairs have been undertaken although there are some examples of inappropriate repointing.
- 9.11 Late 19th - 20th century buildings and alterations have decorative tile-hung walls and gables. This is particularly characteristic of the eastern end of the village (see Figure 24).

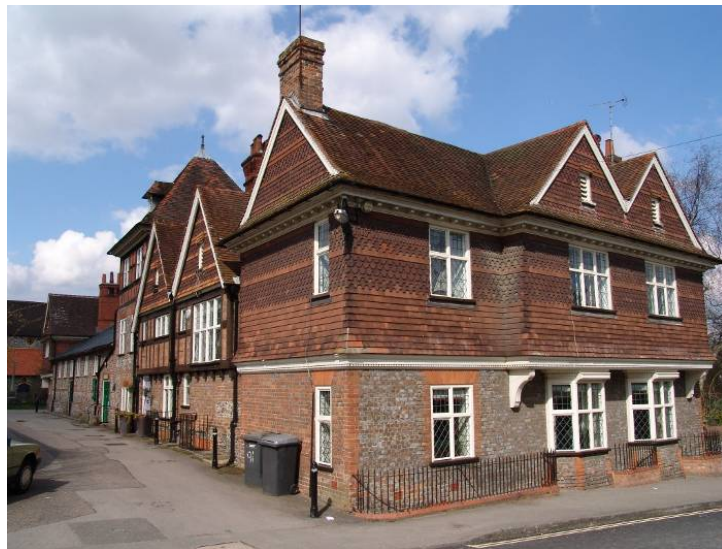
Figure 24: Ravenscroft's Domestic Revival redevelopment of former maltings

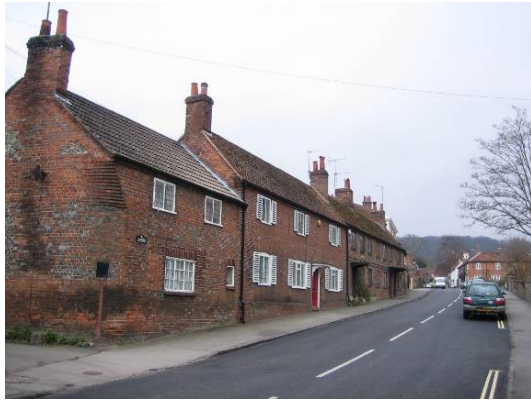
Figure 25: Horizontal emphasis of Icknield Cottages

- 9.12 Buildings in High Street such as Icknield Cottages and Middle House have a strong horizontal emphasis as illustrated at Figure 25. This emphasis results from the proportions of the long two-storey buildings; from the wide window openings (subdivided into narrow casements); from the unbroken eaves and (save for chimneys) ridge lines; from the brick plinths; and from the brick plat bands introduced to articulate the facades. The three-storey Streatley House, illustrated at Figure 26, provides contrast, with its parapet, tall chimneys, elegant sliding sash windows and rusticated stucco quoins, the latter forming strong vertical elements emphasising the corners of the building.

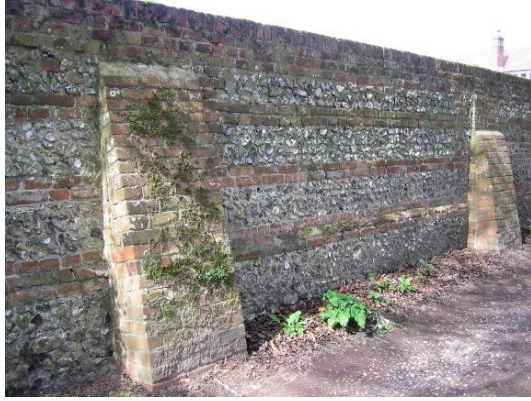
Figure 27: Flint with brick lacing courses and tapering buttresses in Vicarage Lane

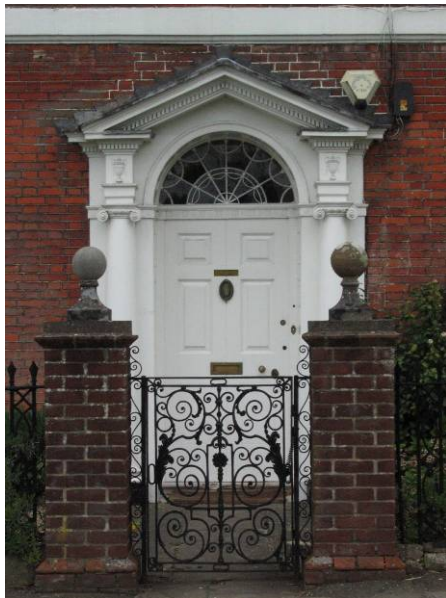
Figure 29: Entrance to Streatley House with door surround, brick piers and iron gate

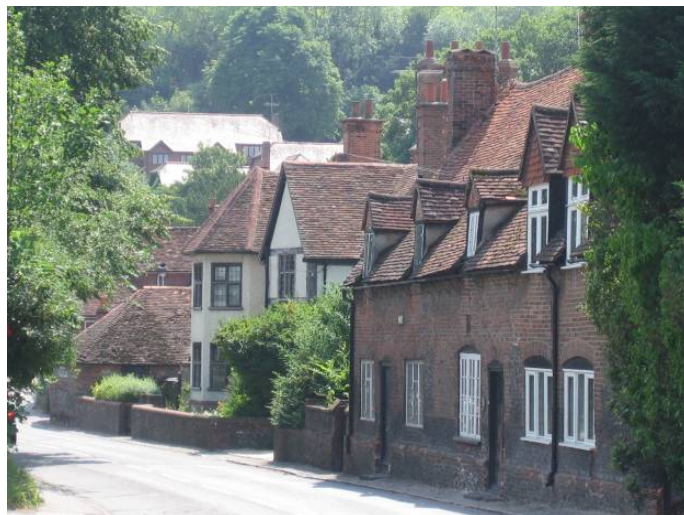
Figure 62: Roofs of the modern Hill Gardens development adversely affect the setting of the conservation area

- 13.3 Late 19th - century development along Wantage Road was augmented in the years between 1900 and 1914 by properties extending along Rectory Road and with the creation of Townsend Road linking Wantage Road with Wallingford Road. As the 20th century progressed, the focus of new building was centred along The Coombe, where buildings dating from the 1930s onwards can be seen. A number of additional houses were built in the later 20th century, principally to the south of Streatley Hill and, within the conservation area, along the eastern side of Wallingford Road as noted above. Some modern development to the south of Streatley Hill, located on the rising ground to the west of the village has a detrimental effect on the setting of the conservation area as illustrated at Figure 62.

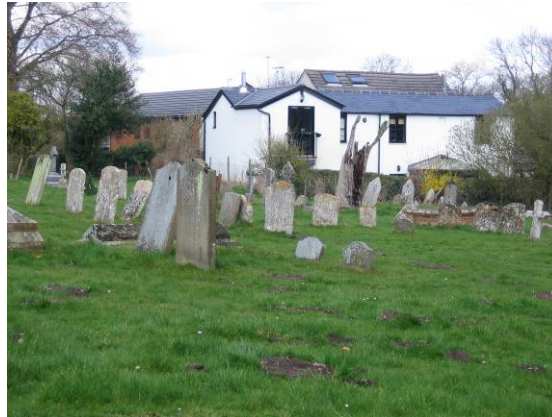
Figure 63: Development beyond the eastern boundary of the church yard

detrimental effect on the character of the conservation area. Examples include development at the eastern boundary of the churchyard, illustrated at Figure 63, which does not blend well with its setting; and the extensive concrete block paving and incongruous conifer hedge to the car park at the Swan Hotel which is flanked on two sides by the conservation area and which contains a prominent mature oak which is visible from a wide area.

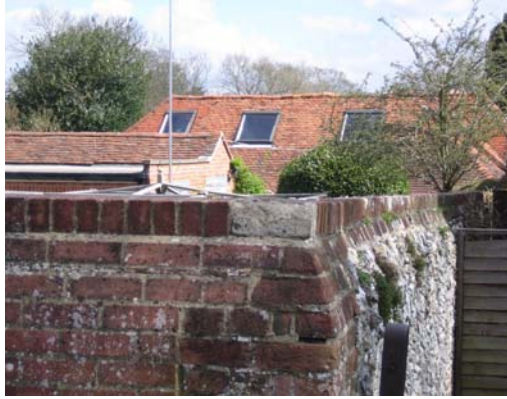
Figure 64: Rooflights

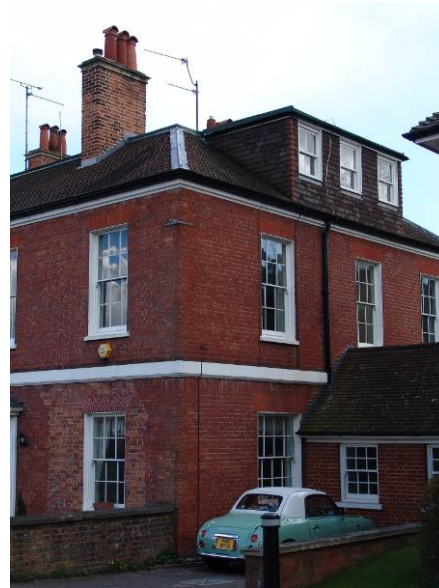
Figure 65: Modern dormers

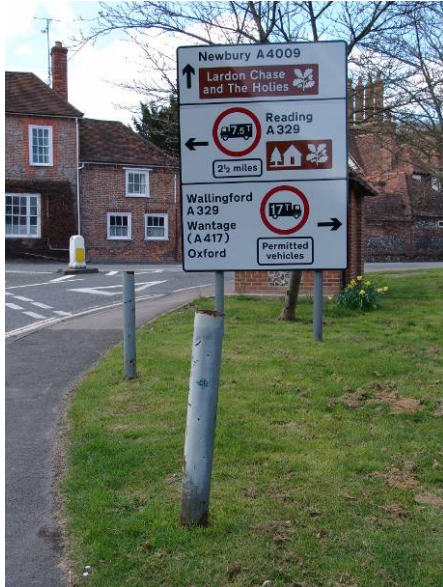
Figure 67: Redundant posts

15.8 There are a number of issues affecting the conservation area which relate to signage, street furniture, bollards and litter bins. The junction between High Street and Reading Road in particular suffers from a proliferation of street furniture. This includes redundant metal posts as shown at Figure 67 and a concrete post north of the bus shelter.
