Sandleford Park West  
Newbury

## **Arboricultural Impact Assessment**

February 2020  
9219\_AIA.004 Rev C

Project Details	
<b>Client:</b>	Donnington New Homes
<b>Project:</b>	Sandleford Park West, Newbury
<b>Report Title:</b>	Arboricultural Impact Assessment
<b>Project Number:</b>	9219
<b>File Reference:</b>	9219_AIA.004 Rev C
<b>Date:</b>	01/02/2020

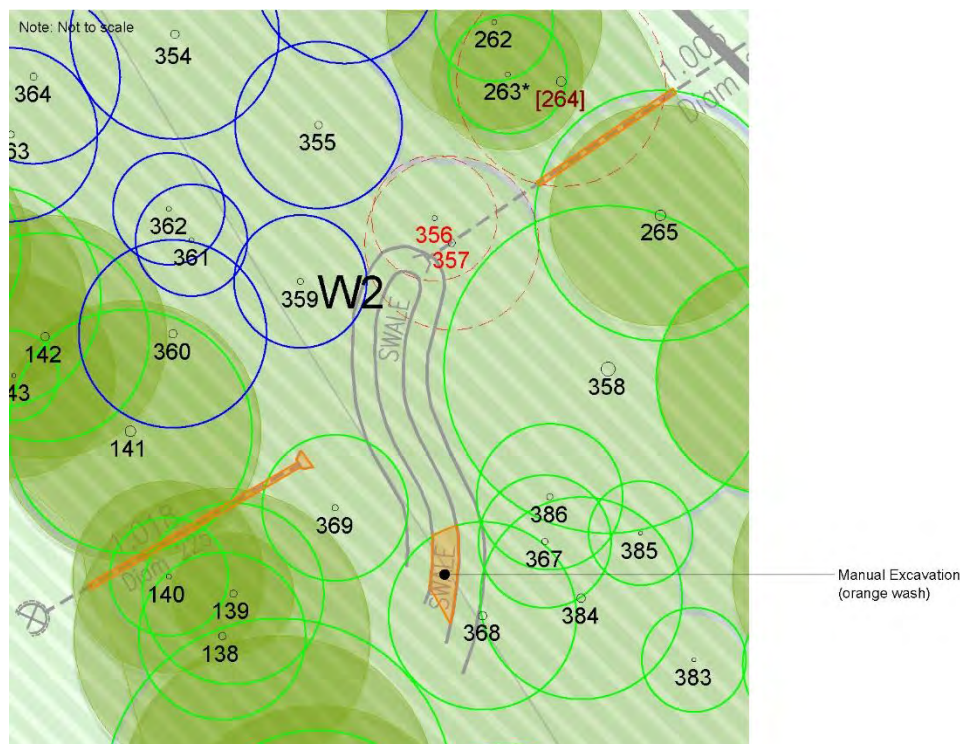
4.2.8 Figure 1. Brick Kiln Copse: Supervised Excavation

- 4.2.7 As a precautionary measure, and to minimise root severance, the excavation works detailed above should be carried out under direct arboricultural supervision following the guidance contained within section 7.2 of BS5837:2012.

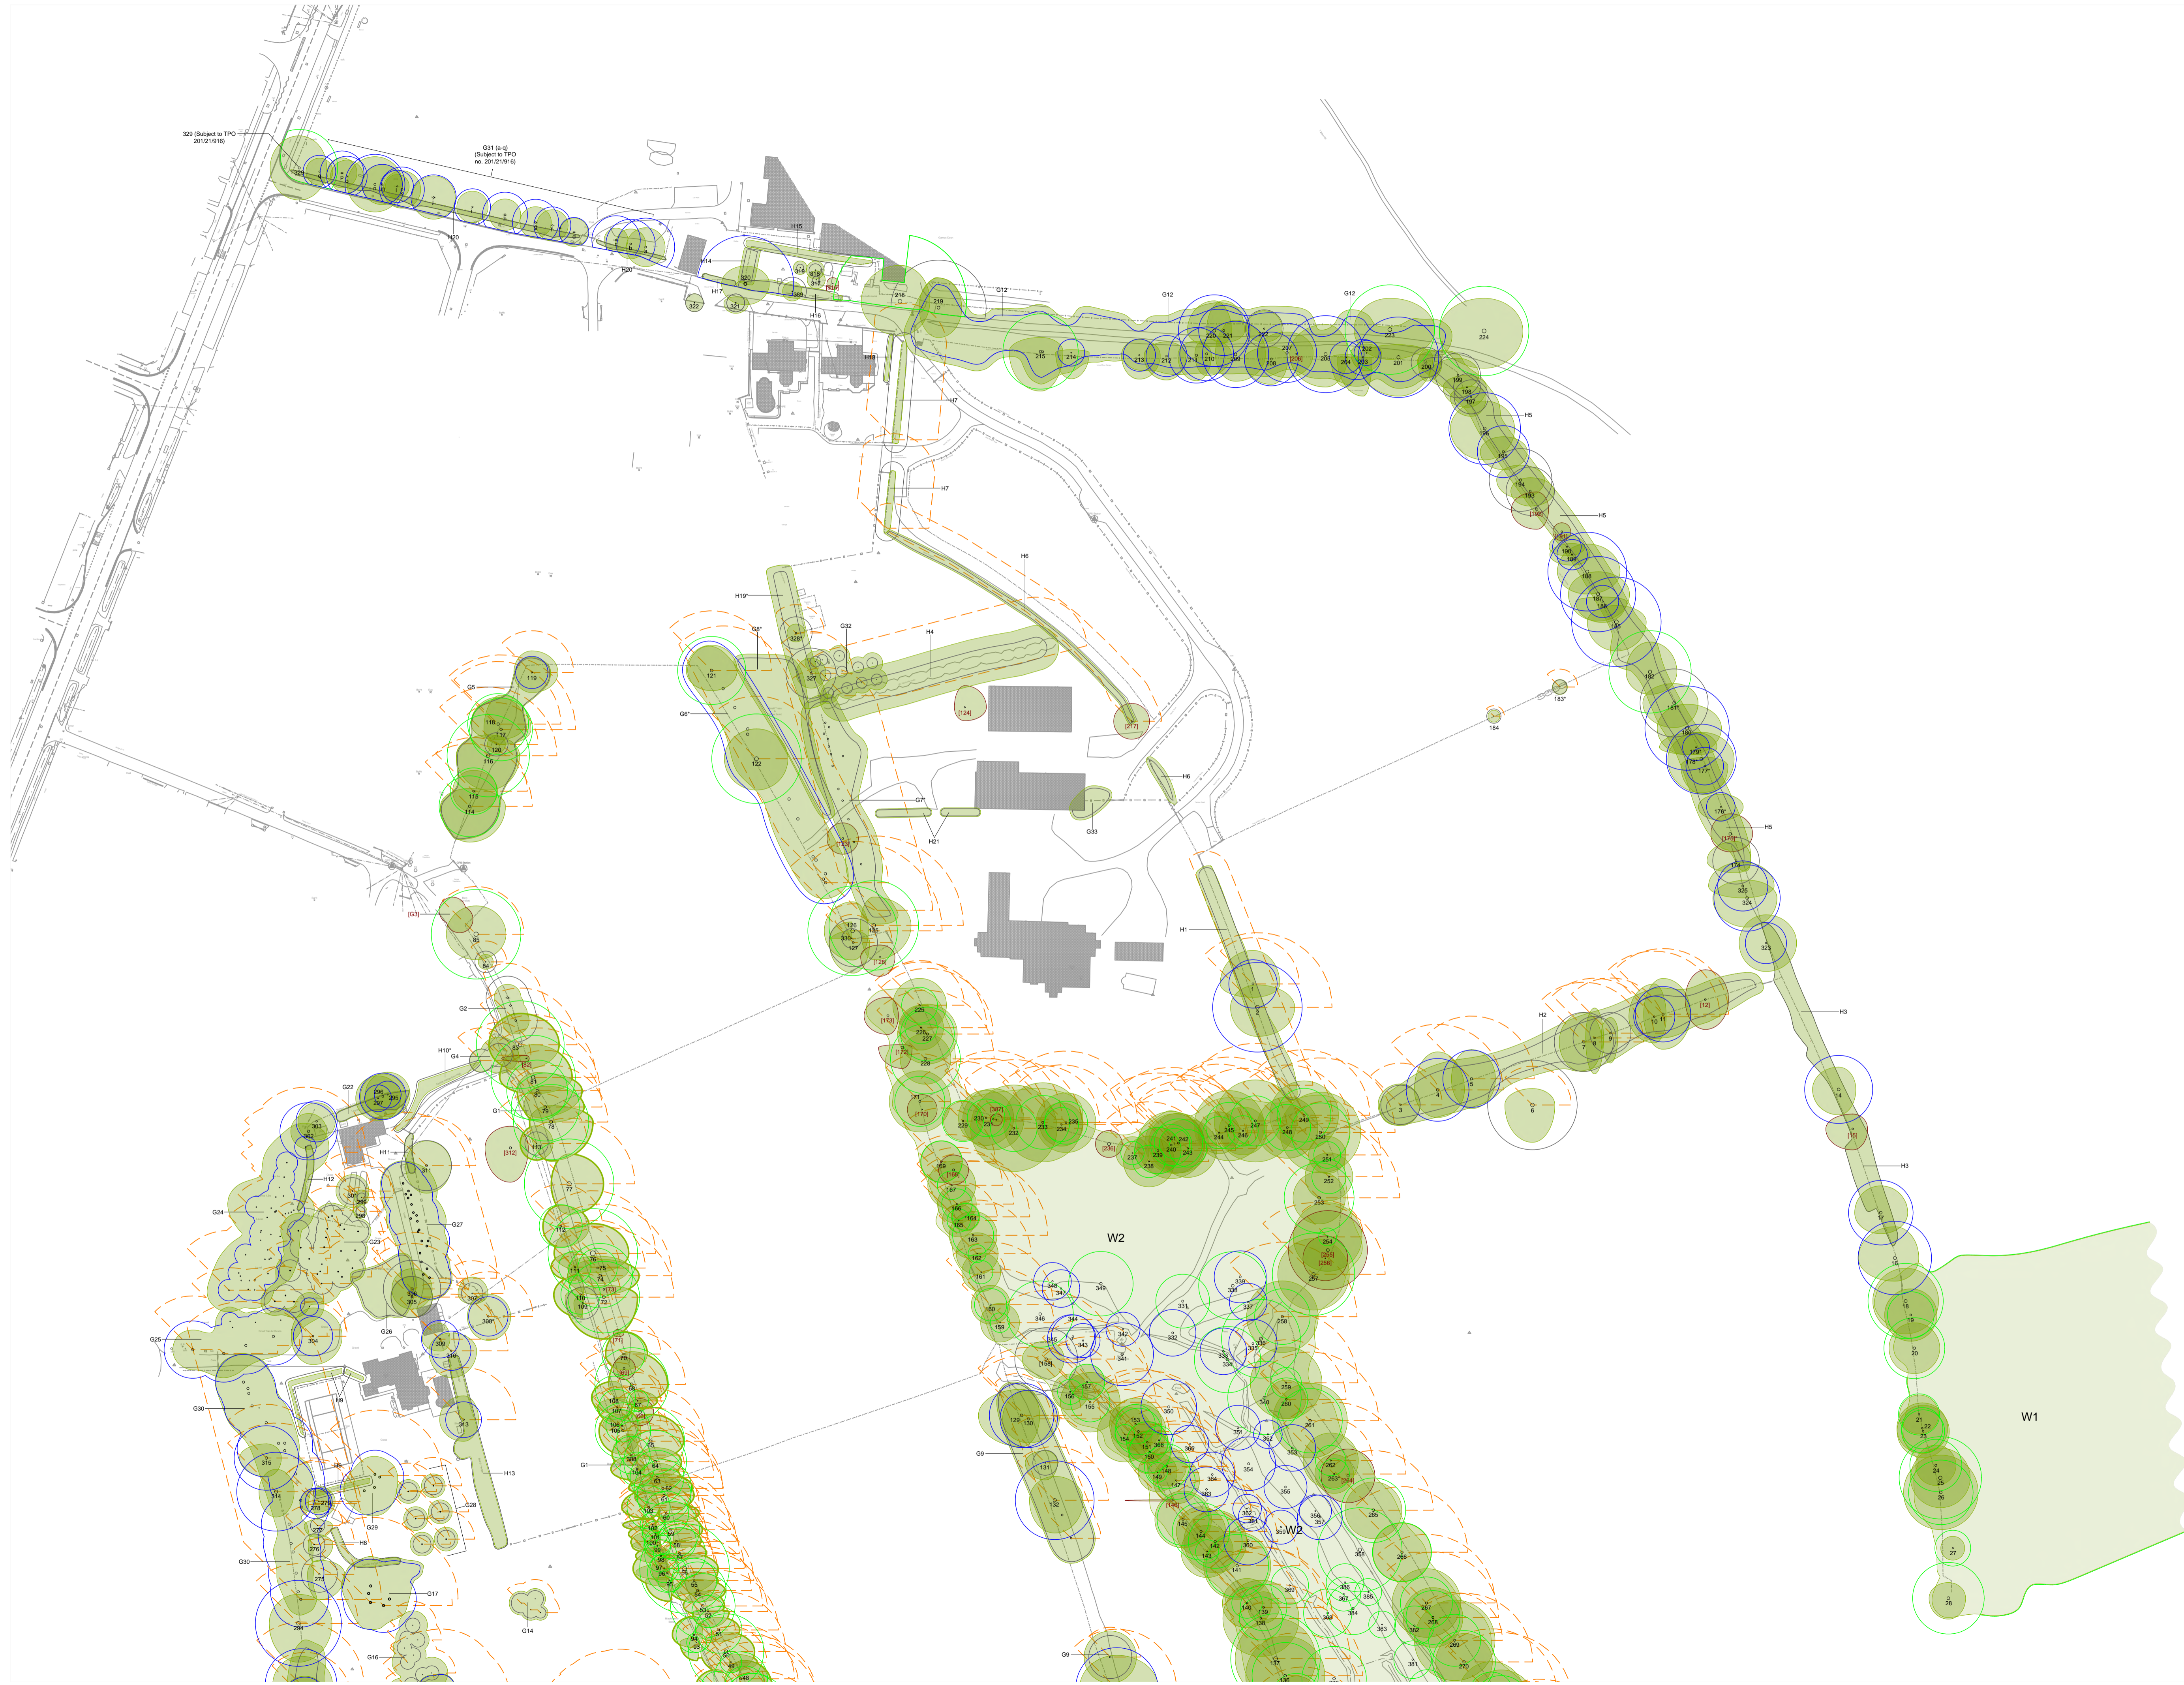
TREE CONSTRAINTS PLAN (9219 TCP 04 Rev A)

Note: Trees 175-179, 181, 183, 263, 308, 328, 387-389, Groups G6-G8, G18, G21 and Hedgerows H10 and H19 have been plotted using measurements onsite in conjunction with aerial imagery. Their locations were not recorded on the topographical survey of the site.

Note: The RPA footprint for trees 218, 219, 320, 329, 389 and group G31 (a-d, f-k & m-q) have been displaced to allow for the effect of the adopted highway. The surface area of the RPA has not been reduced.

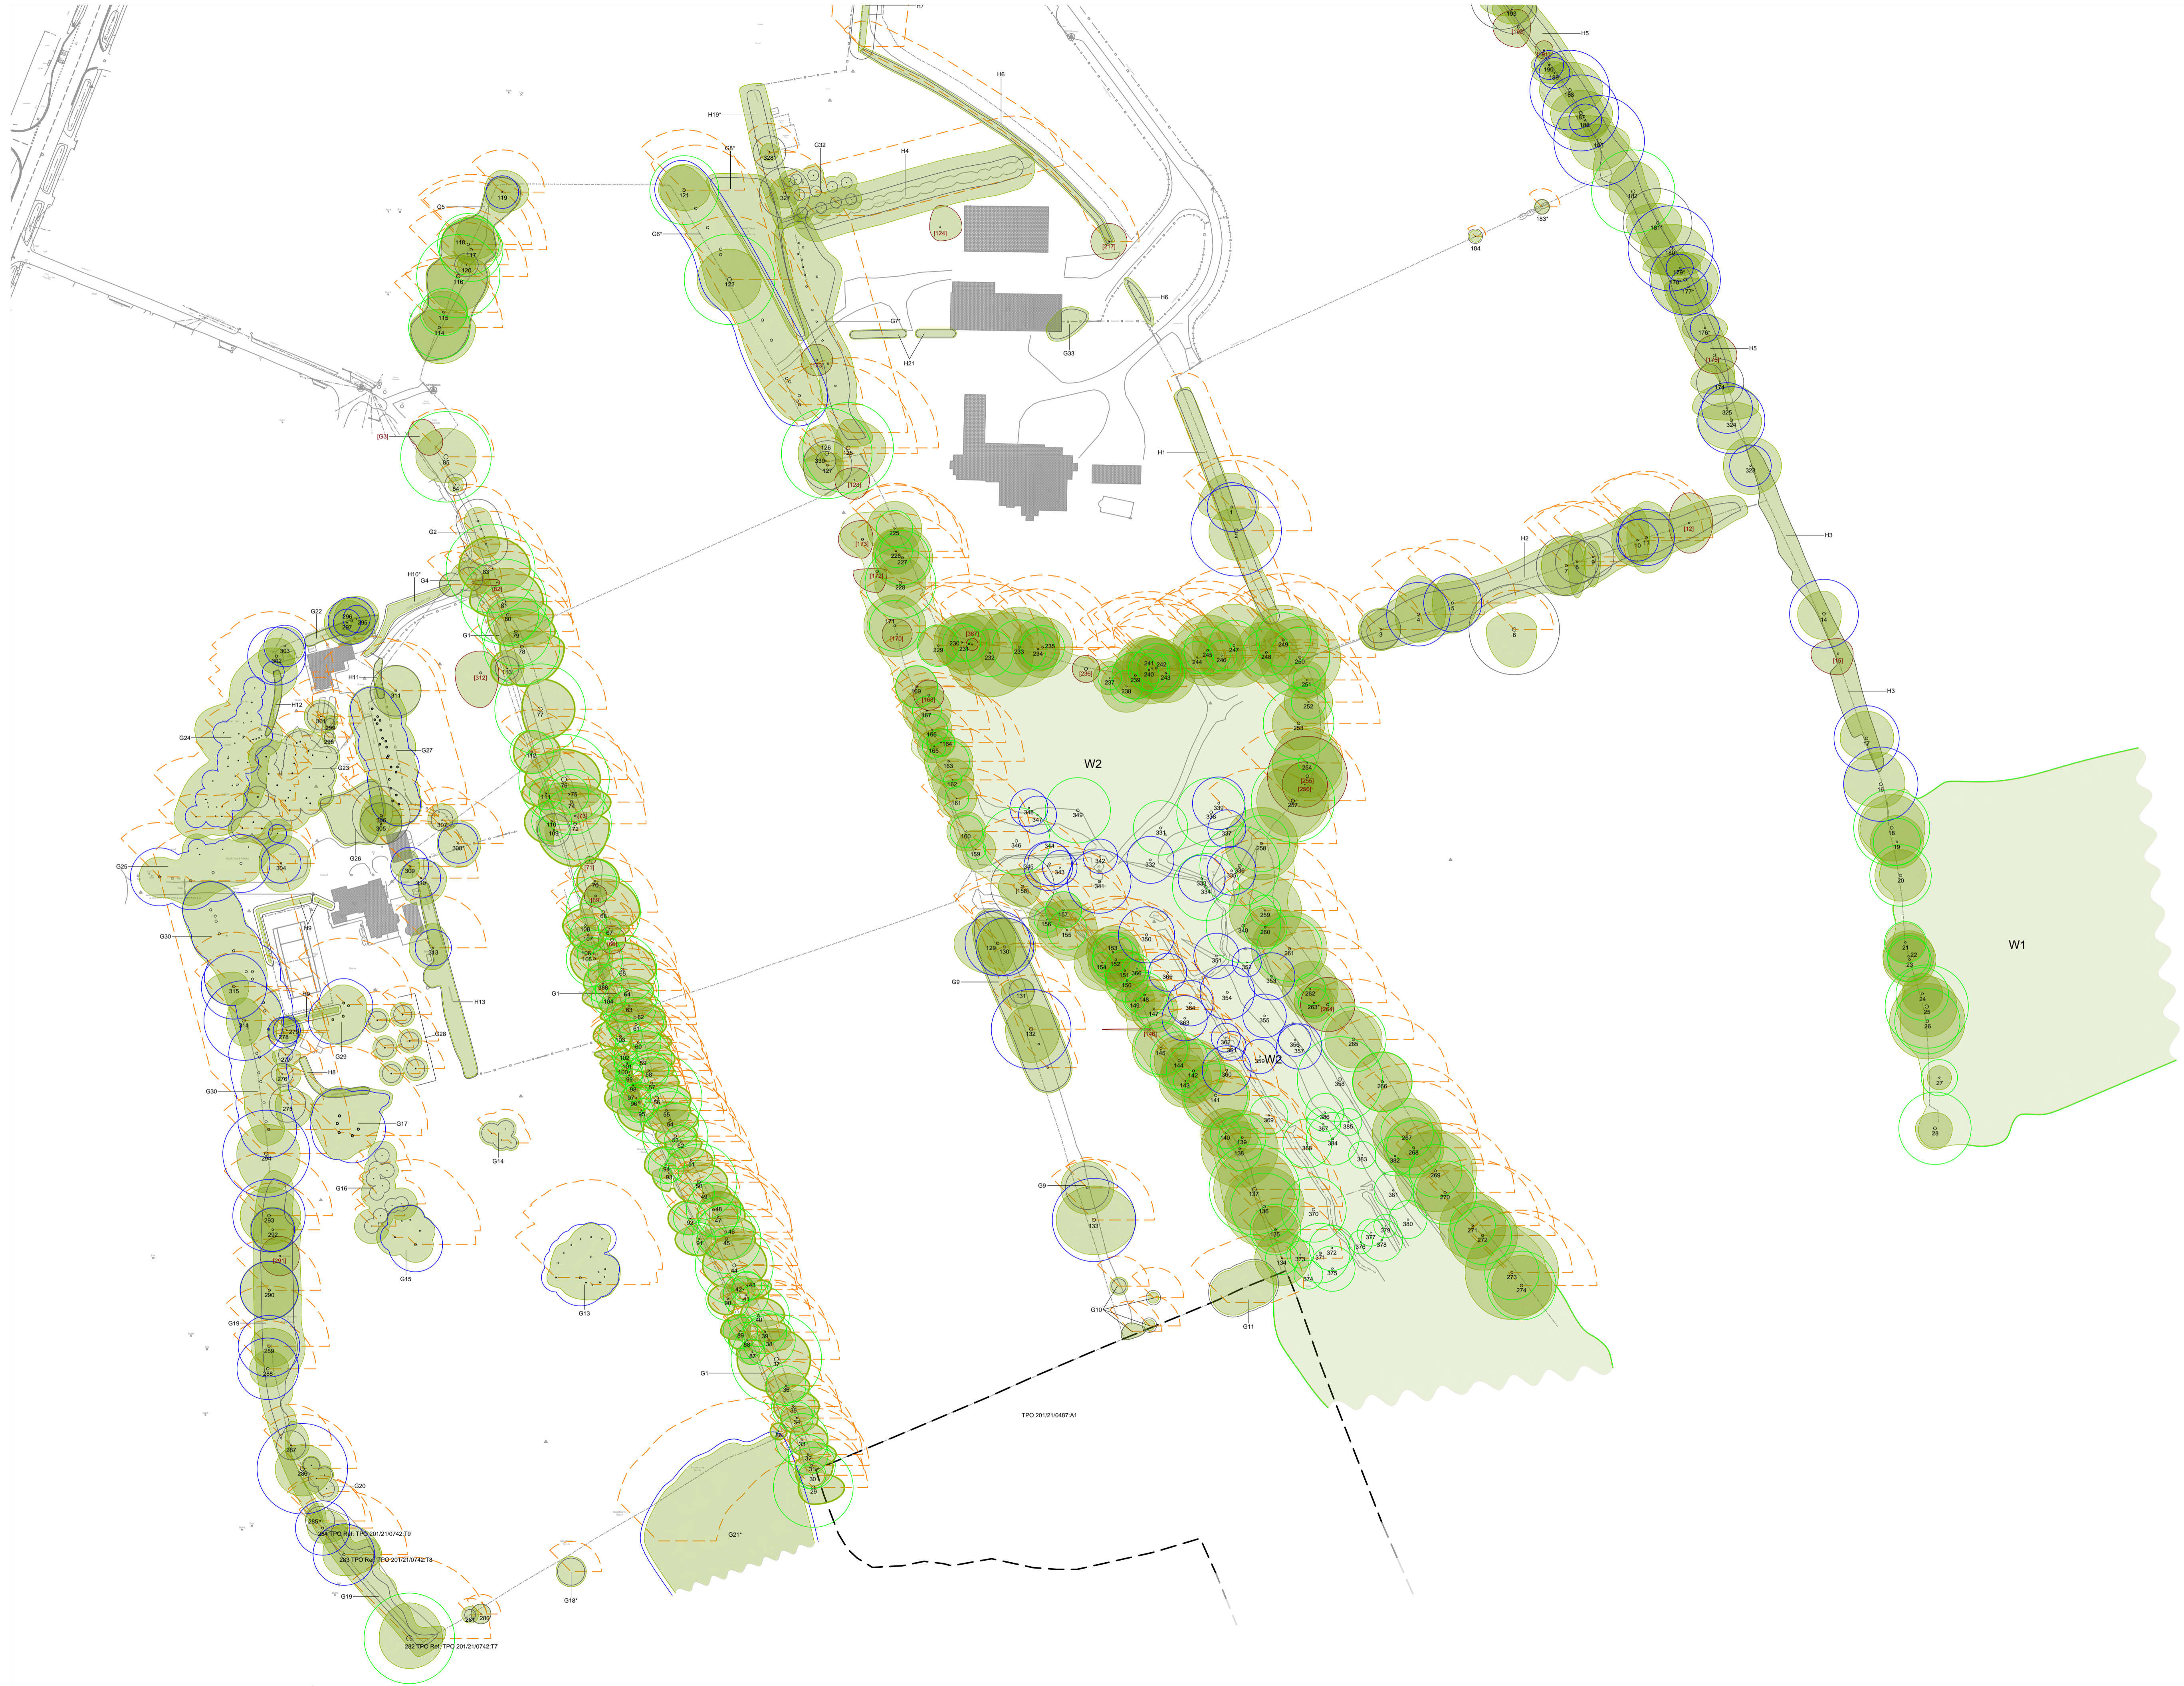
DRAWING NUMBER: 9219 TCP 04 (North) REVISION: A

Note: Trees 175-179, 181, 183, 263, 308, 328, 387-389, Groups G6-G8, G18, G21 and Hedgerows H10 and H19 have been plotted using measurements onsite in conjunction with aerial imagery. Their locations were not recorded on the topographical survey of the site.

Note: The RPA footprint for trees 218, 219, 320, 329, 389 and group G31 (a-d, f-k & m-q) have been displaced to allow for the effect of the adopted highway. The surface area of the RPA has not been reduced.

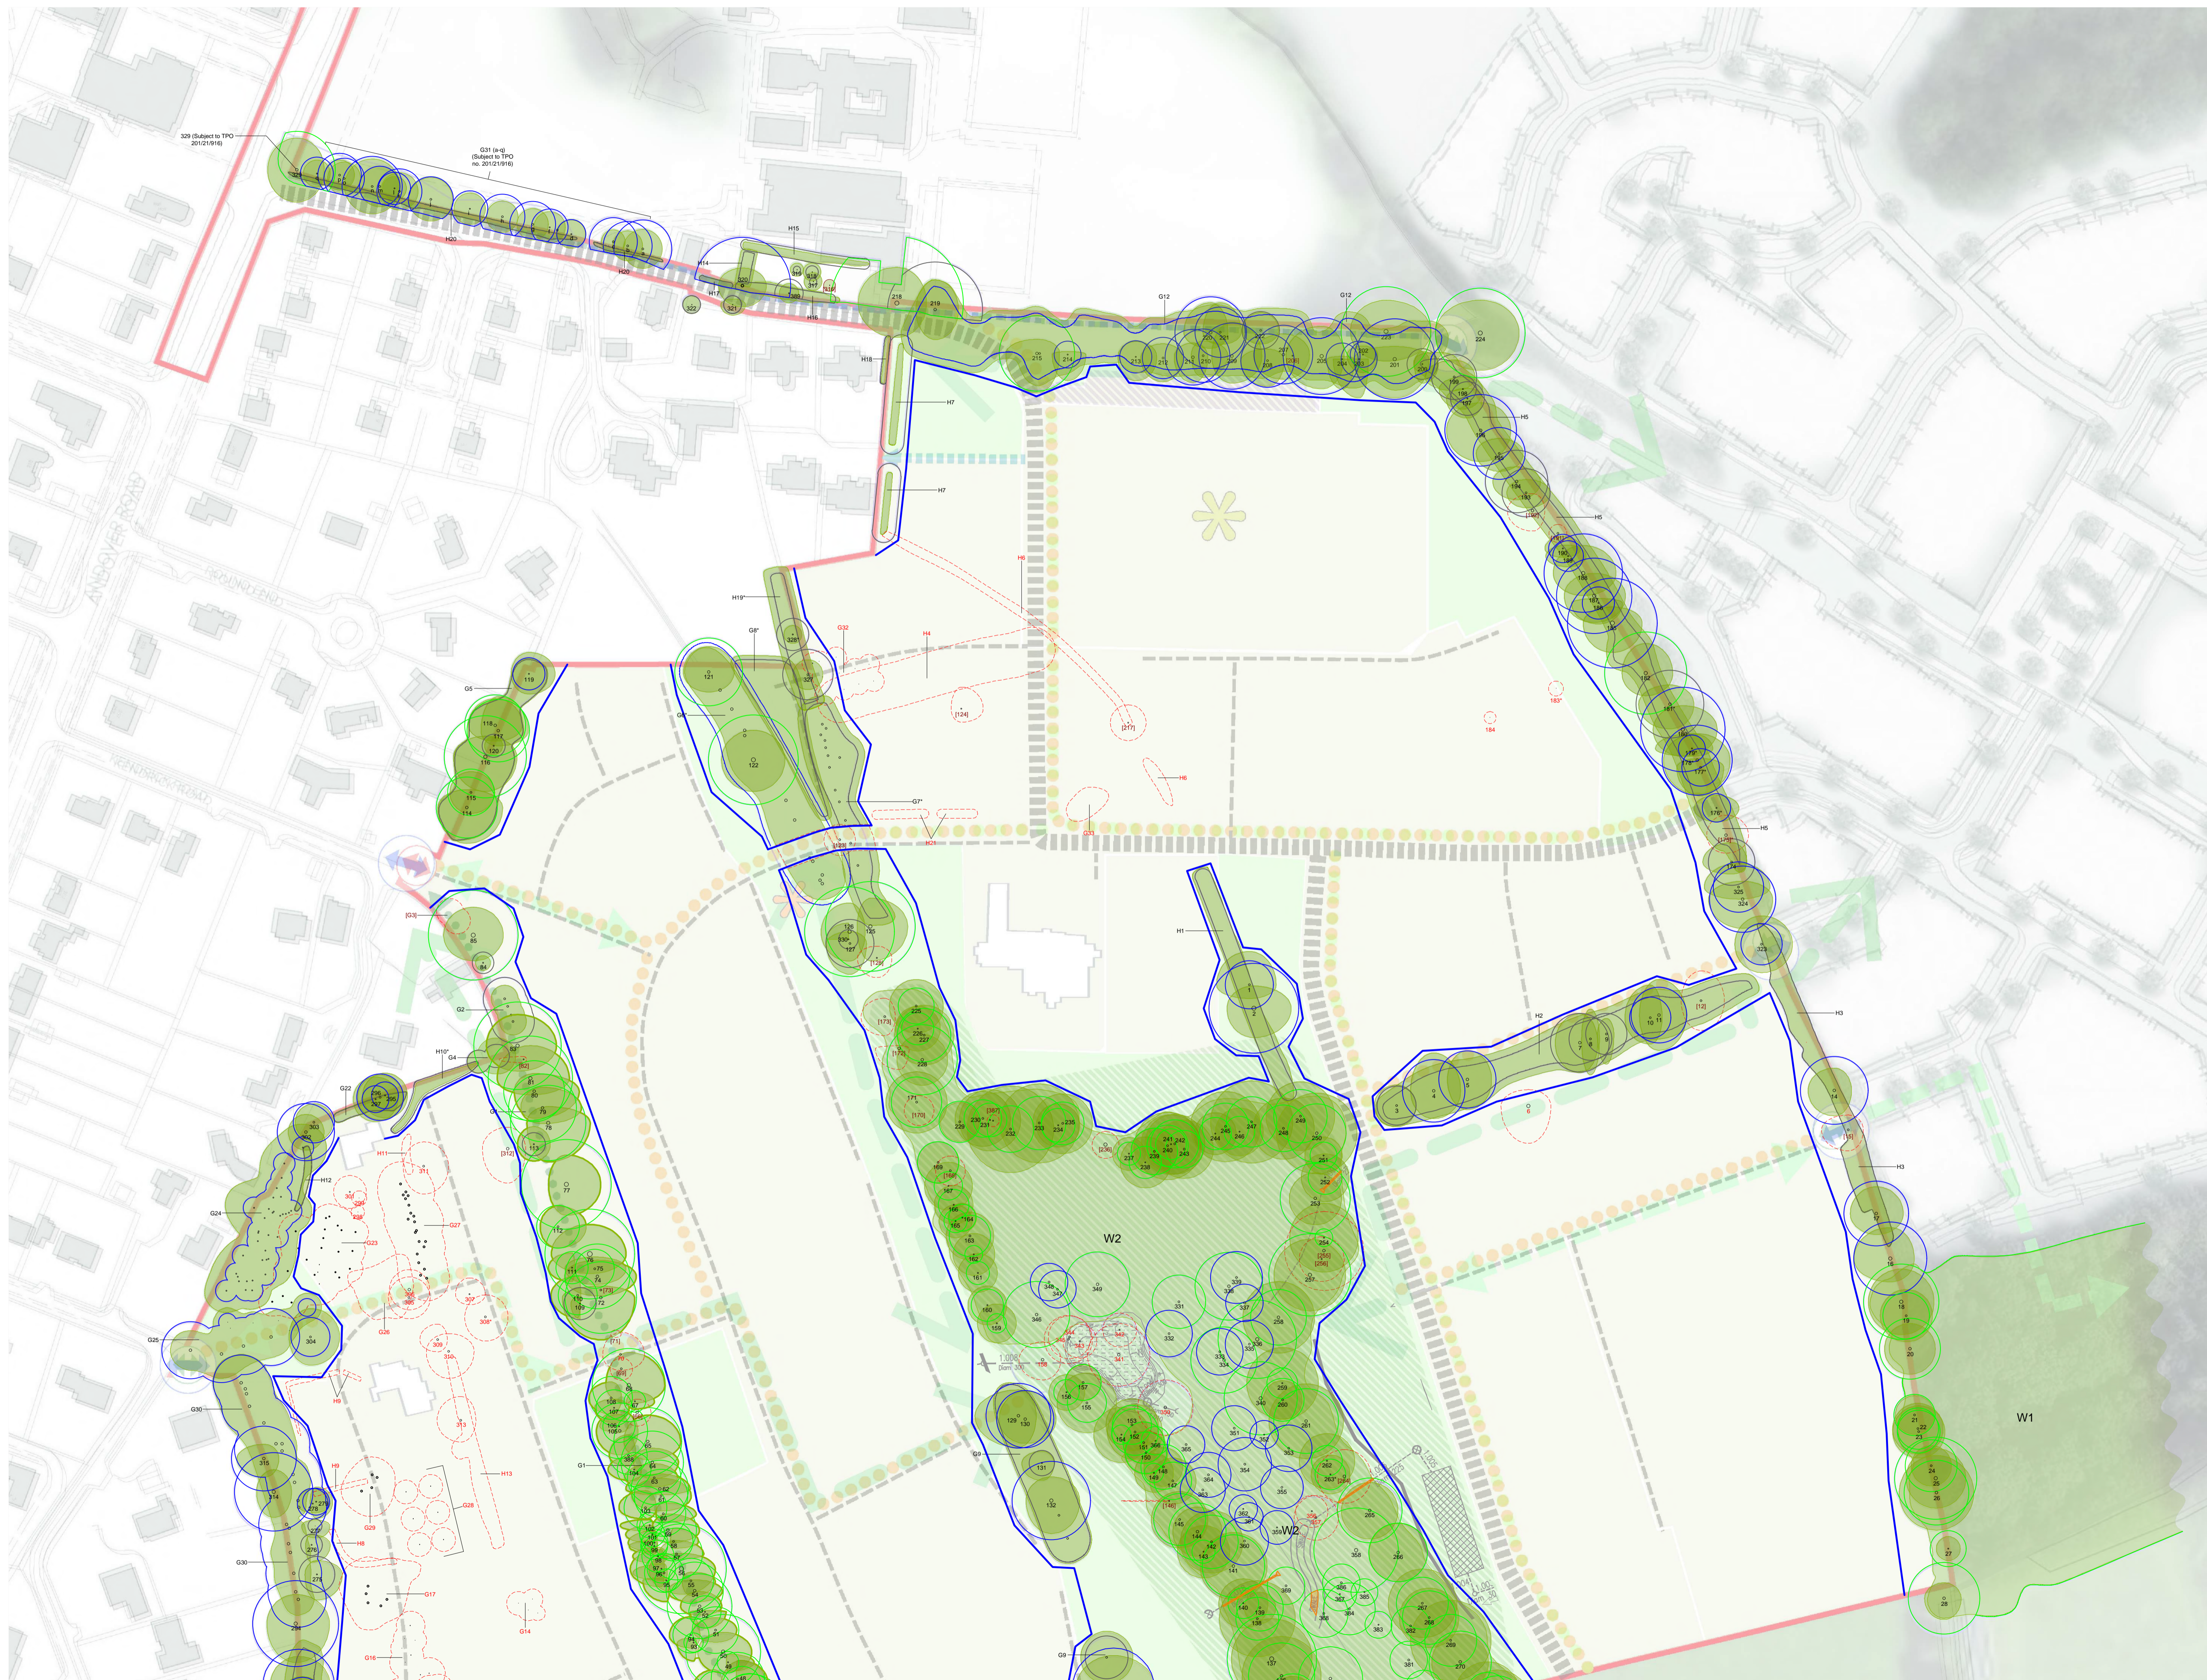
TREE PROTECTION PLAN (9219 TPP 05 Rev A)

Note: Trees 175-179, 181, 183, 263, 308, 328, 387-389, Groups G6-G8, G18, G21 and Hedgerows H10 and H19 have been plotted using measurements onsite in conjunction with aerial imagery. Their locations were not recorded on the topographical survey of the site.

Note: The RPA footprint for trees 218, 219, 320, 329, 389 and group G31 (a-d, f-k & m-q) have been displaced to allow for the effect of the adopted highway. The surface area of the RPA has not been reduced.

4.3.1 It will be important to protect retained trees’ above-ground structures and underlying RPAs from damage during construction works. To achieve this, the barrier specification for direct protection should consist of the default specification provided in BS5837:2012, and be erected prior to the commencement of construction works.

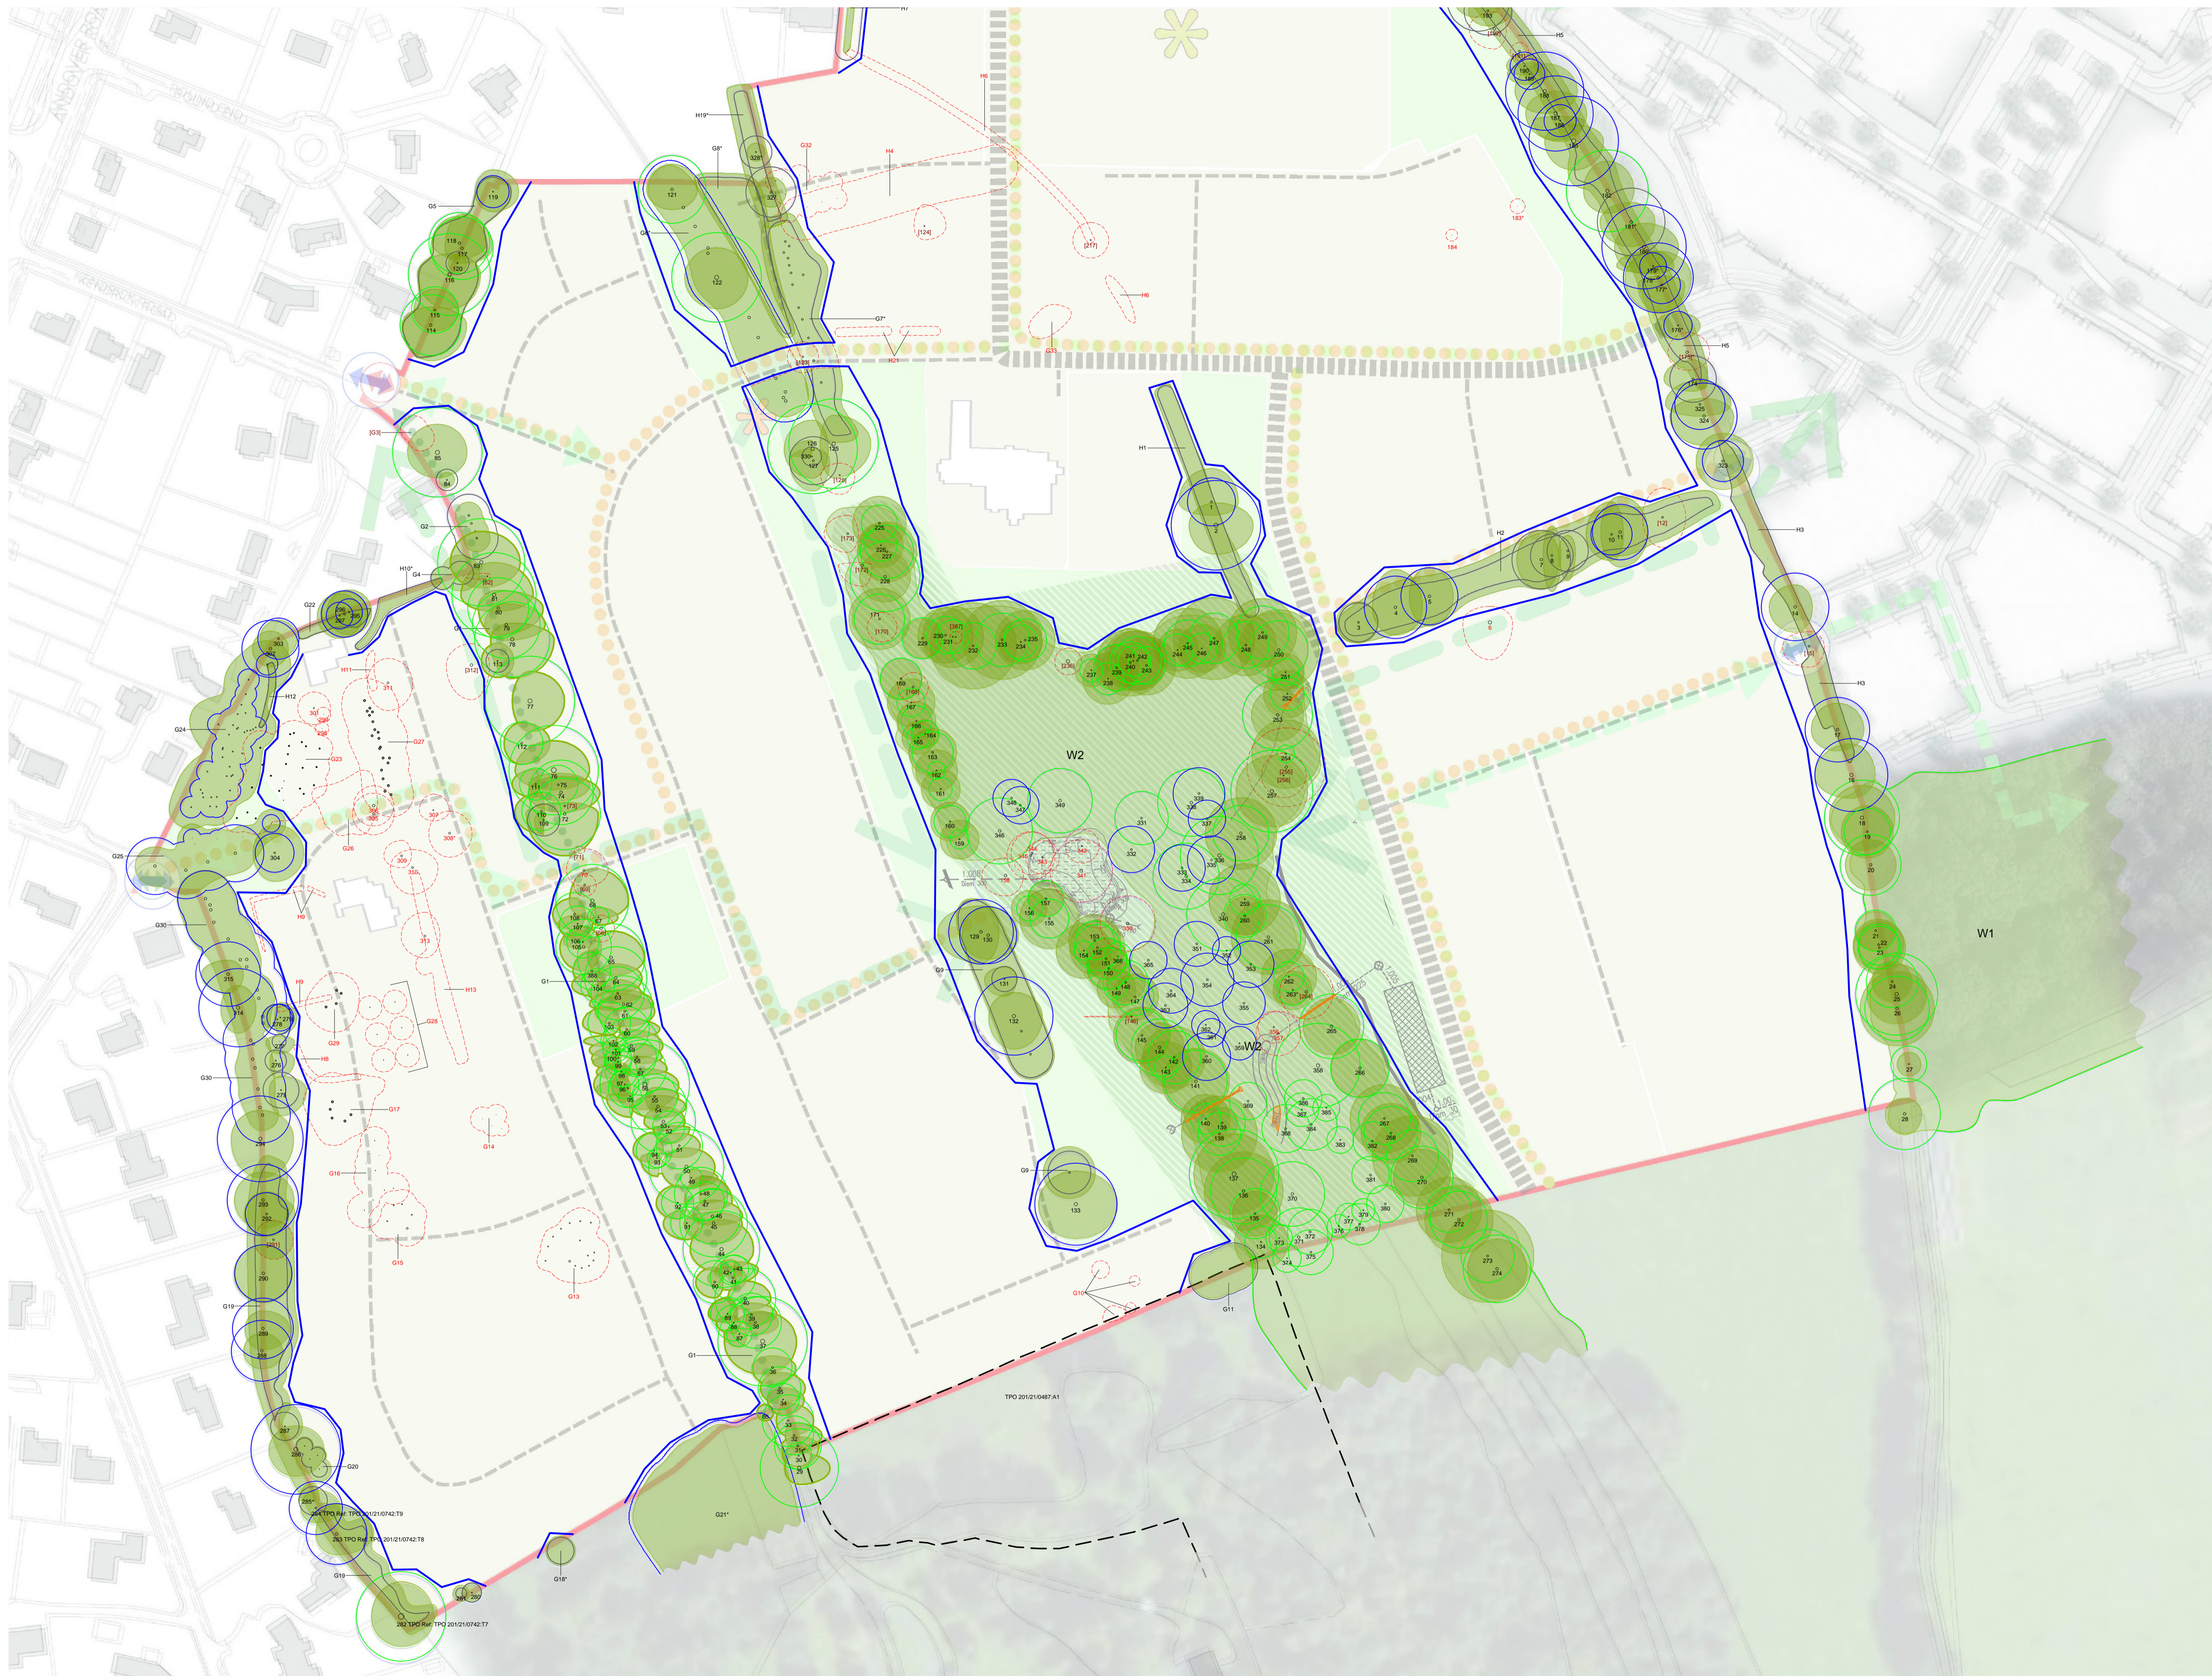
Note: Trees 175-179, 181, 183, 263, 308, 328, 387-389, Groups G6-G8, G18, G21 and Hedgerows H10 and H19 have been plotted using measurements onsite in conjunction with aerial imagery. Their locations were not recorded on the topographical survey of the site.

Note: The RPA footprint for trees 218, 219, 320, 329, 389 and group G31 (a-d, f-k & m-q) have been displaced to allow for the effect of the adopted highway. The surface area of the RPA has not been reduced.
