Sandleford Park, Newbury

Appendix F13: Aquatic Invertebrate Survey Report

Bloor Homes & The Sandleford Farm Partnership

February 2019

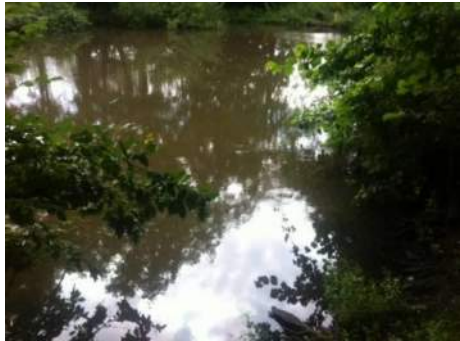
Sample	Grid Reference	Description (2014)	Photograph
S1	SU 47182 64062	Sample taken from shallow edge of pond, approximately 0.5 metres deep but centre of pond likely to be very deep. The water was quite murky / silty. Ducks present on pond. 30% shade around pond. Very little aquatic vegetation present. Set within woodland, with arable fields and set aside beyond the woodland habitat.

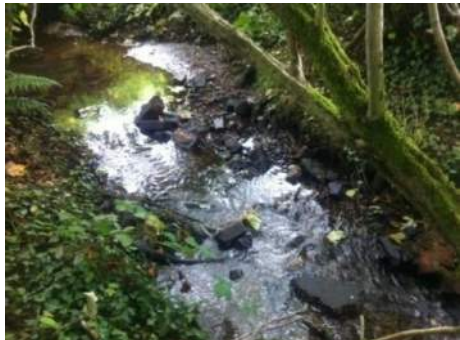
S2	SU 47180 64157	Flowing stream within woodland, upstream from pond. Quite clear water with a stony bed. 95% shade, approximately 20cm deep and 1m wide with quite shallow banks. No aquatic vegetation present.

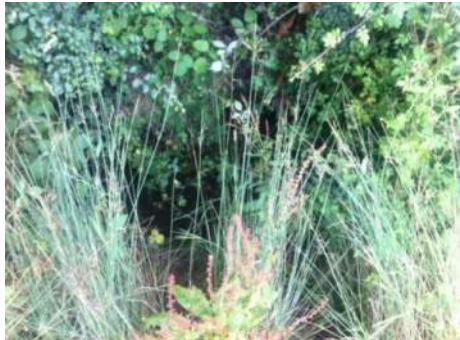
S3	SU 47035 64427	Very slow flowing stream, quite clear with gravel bed. Overhanging trees and bramble so almost completely shaded. Approximately 20cm deep and 60cm wide with very steep banks. No aquatic vegetation present.

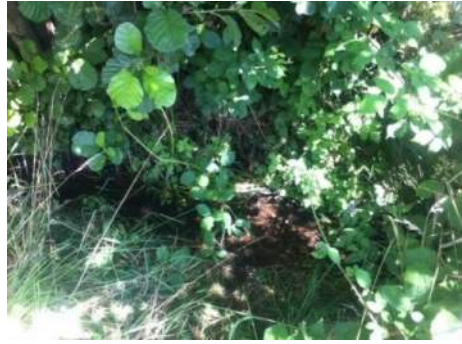
Sample	Grid Reference	Description (2014)	Photograph
S4	SU 46844 64542	Slow flowing stream with clear water, a stony bed and shallow banks. Almost completely shaded by overhanging trees and bramble with no aquatic vegetation present. Approximately 30cm wide and less than 10cm deep.

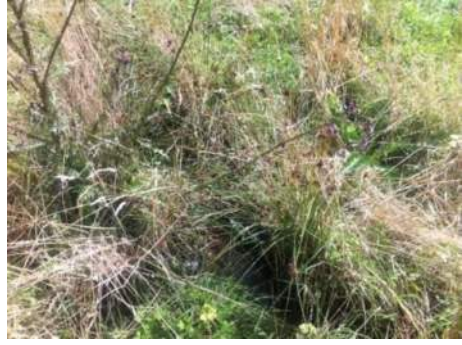
S5	SU 46883 64807	Very slow flowing stream within marshy grassland, with woodland blocks on both sides. Extremely shallow, with a few deeper points which were possible to survey, but no deeper than 10 cm.

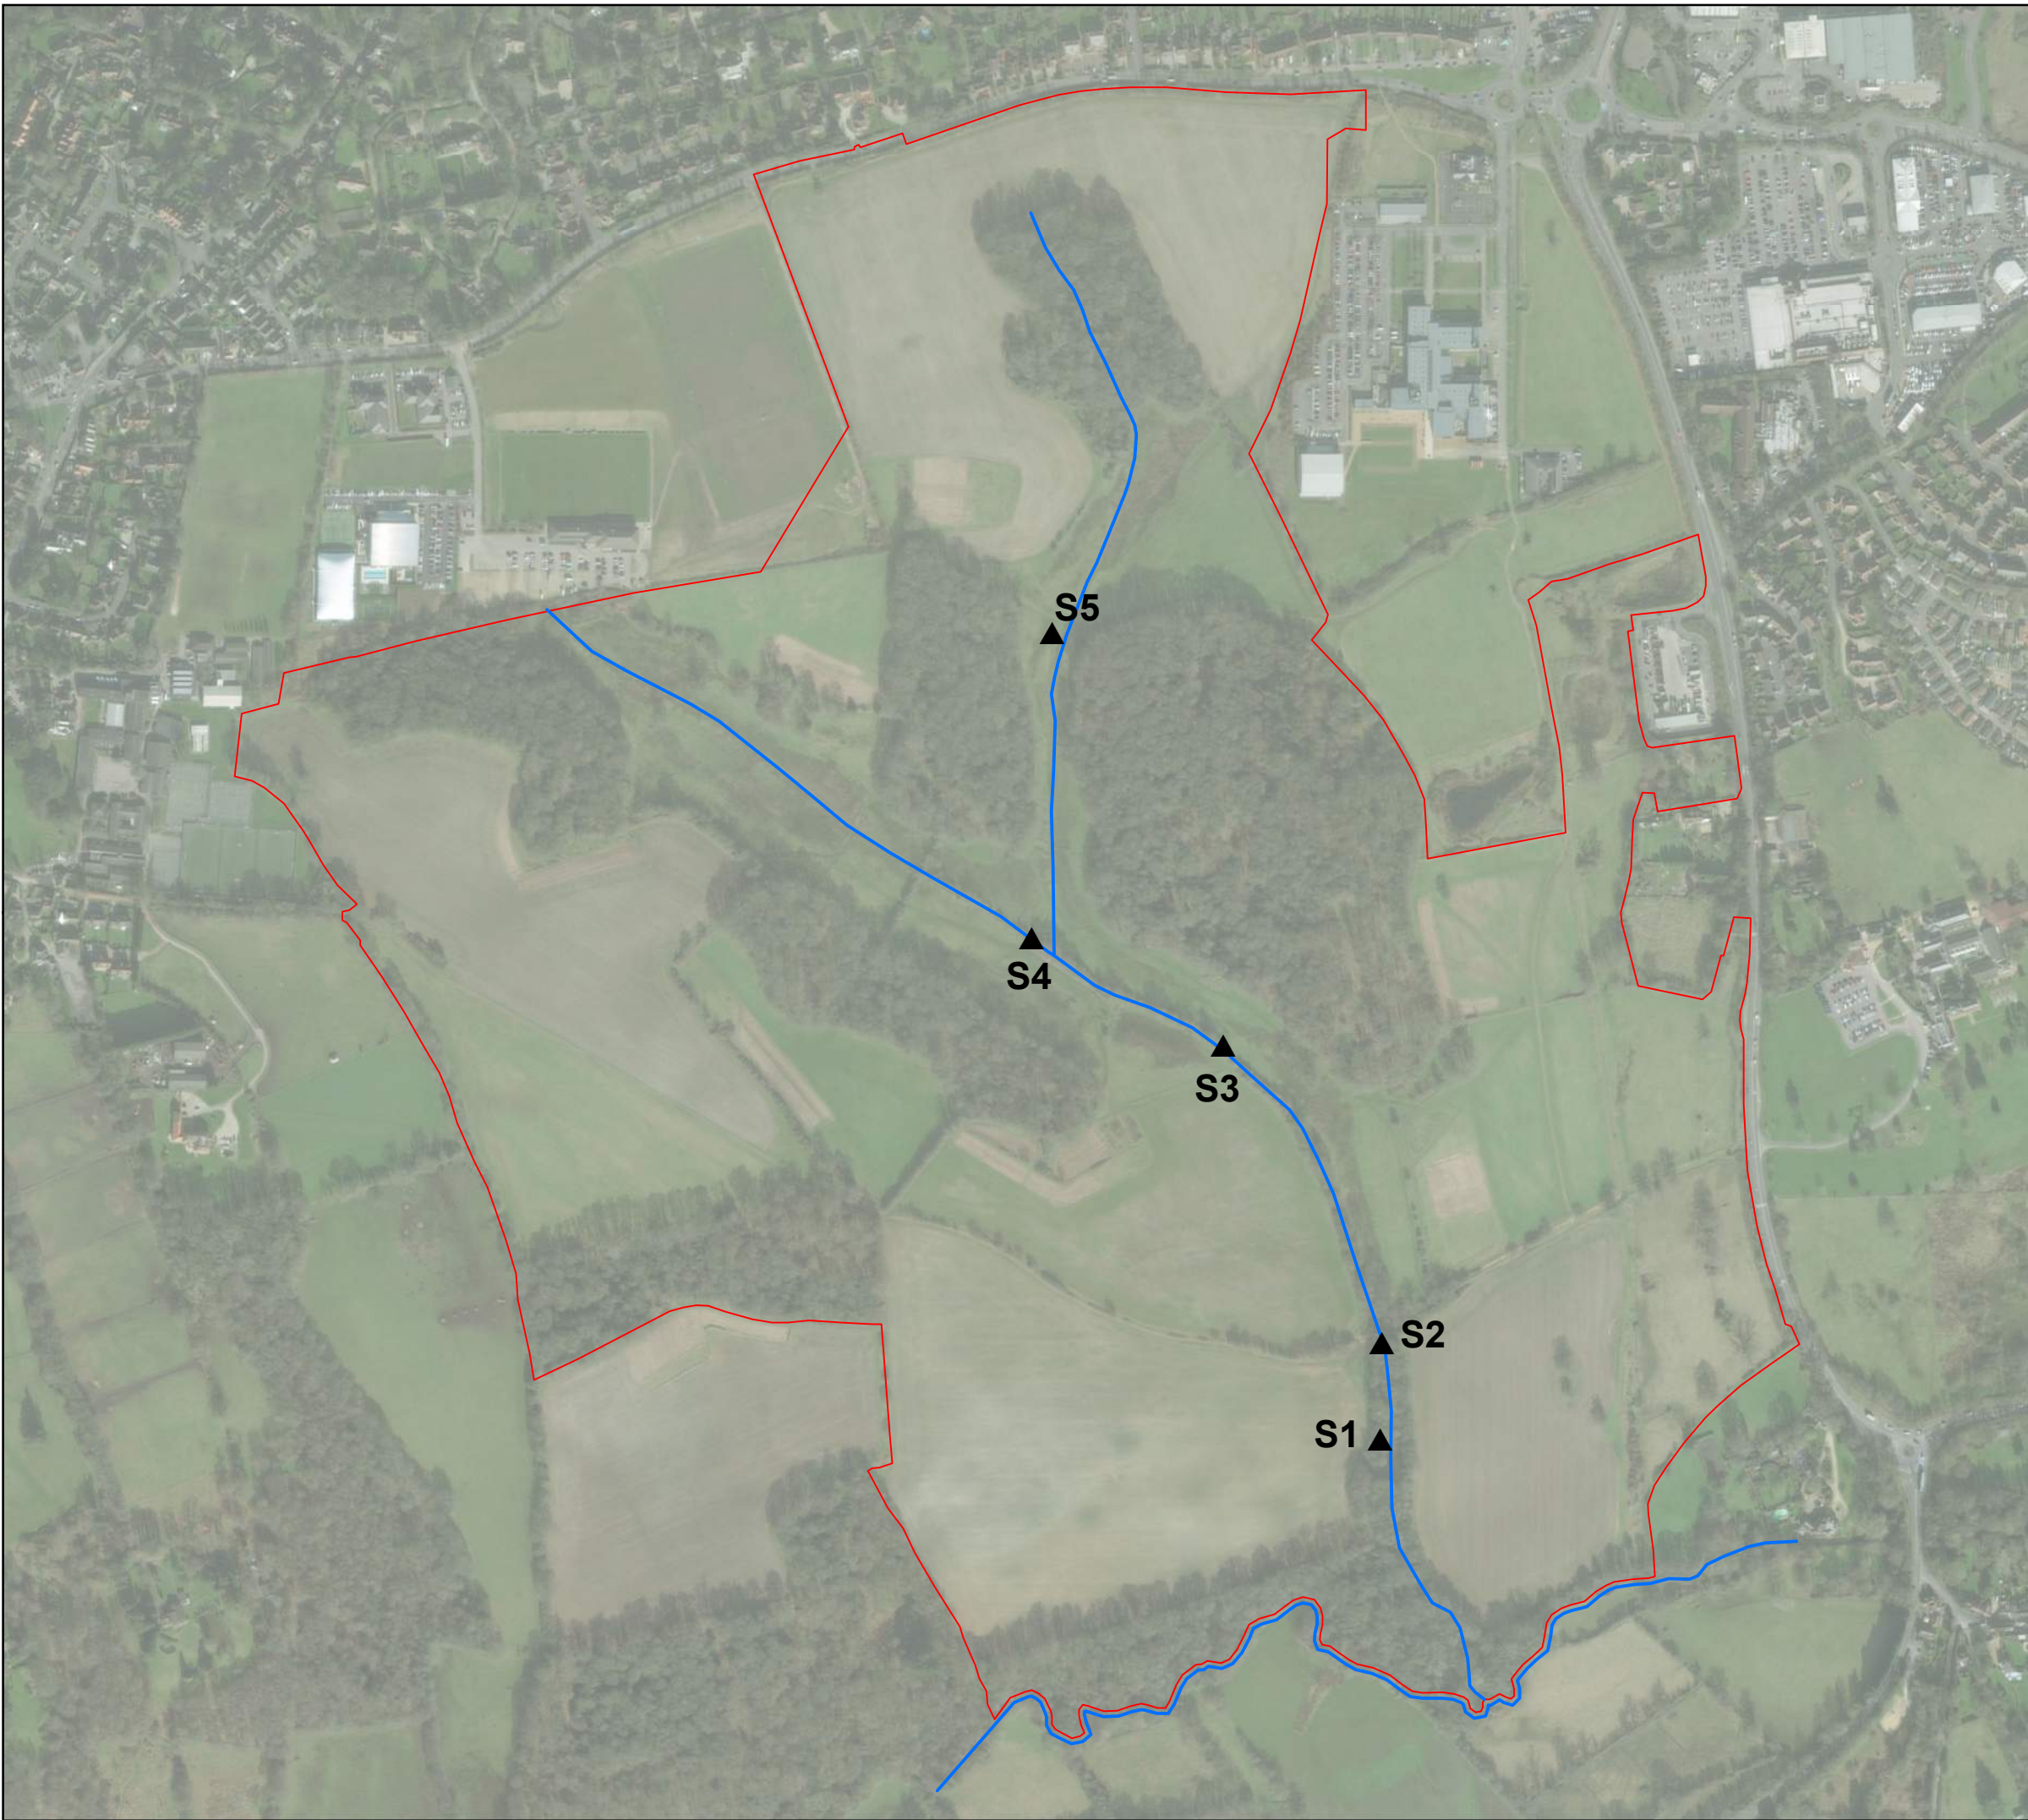
Figure 1 – Aquatic Sample Locations

Aquatic sampling was carried out at five locations (Figure 1, Table 1). Sample points were between OS Grid Reference SU 472 639 to SU 467 645 for the main stream and OS Grid Reference SU 469 649 to SU 468 645 for the drain running into the main stream.
