# HALL PLACE FARM, LITTLE HEATH ROAD, TILEHURST, READING

**Heritage Impact Assessment**

Prepared for: The Sulham Estate

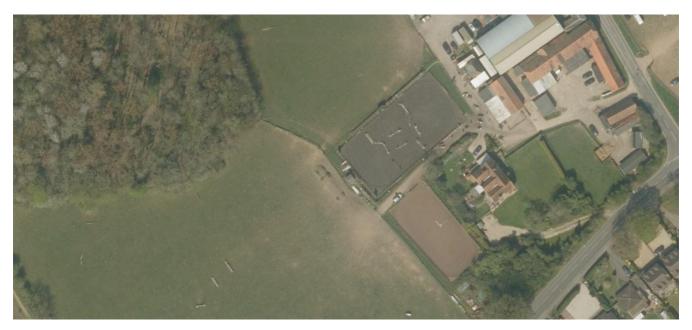
grassed and open landscape. The farmhouse itself is a building that has developed over c.300 hundred years and comprises a south-facing frontage with a north range attached to the eastern side (Figure 2). Two later bays are attached to the western side of the north range, so that three gable ends face west (Appendix 1 Plate 1). More modern additions of low quality are attached to the northern part of the house (Appendix 1 Plate 2). The main outlook was therefore designed to the south and east where the present gardens extend, whilst to the west more intimate garden spaces are hedged in quite close to the building. A low hedge also encloses the northern part of the surrounding garden. This suggests that views west from the gables were of secondary importance, whilst the north side was used principally as a service entry.

In the case of Hall Place Farmhouse the immediate setting is the farmyard and related agricultural buildings which comprise the core economic unit (now mostly of an equine nature) (Figure 2). The adjacent fields would make a wider contribution to the heritage significance of the listed building through the fact that they maintain the relationship between a farm and its working landscape. Field 1 to the north-west of the farm includes modern clutter, that detracts from appreciation of the listed building, and so at present it makes a negative contribution (Appendix 1, Plate 10), whereas Field 2 to the south-west provides more of a positive contribution through its

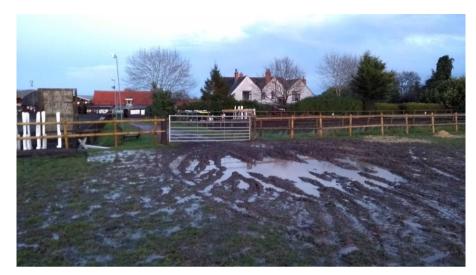
The Hall Place Farm listing (NHLE 1215861) comprises a building that is now divided into two. It is in origin a two storey, 16<sup>th</sup>/17<sup>th</sup> century timber-framed farmhouse with brick additions. It has an old tiled roof, and five chimney stacks, but most of the windows have been replaced in the 20<sup>th</sup> century (Appendix 1 Figures 1 & 2).

Figure 1 Hall Place Farm from the south

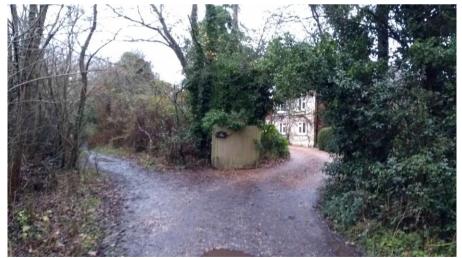
Kiln Cottage (NHLE 1215860) is of 17<sup>th</sup> century date, a three-bayed, two storeyed, timber-framed construction with brick infill. It has an old tiled and hipped roof, and is set back at the end of Kiln Lane in its own land, facing south-east (Appendix 1 Figures 3 & 4).

Figure 3 Kiln Lane and Kiln Cottage with footpath heading west

Kiln Cottage has a narrower setting, as the term cottage implies (Appendix 1 Plates 3-4). The immediate setting is the land holding in which it is located and the access to this, Kiln Lane and the footpath that continues westwards to the south of the house. The name must relate to the general location of brick and tile making within the vicinity, unless there is a kiln within the garden which is now buried and unknown. The plot of land in which the cottage is situated is relatively large and could once have extended east to Little Heath Road. A kiln within this land holding would be a definite possibility and the size of the cottage suggests the owner was more important than a farm labourer or industrial workman. At present Kiln Cottage and its curtilage are surrounded by trees, and housing development within the fields to the north or south would be unlikely to significantly change the contribution that setting makes to its heritage significance.

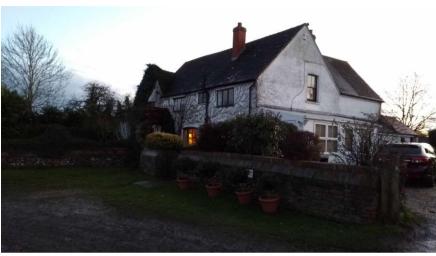
Figure 2 Hall Place Farm from the north

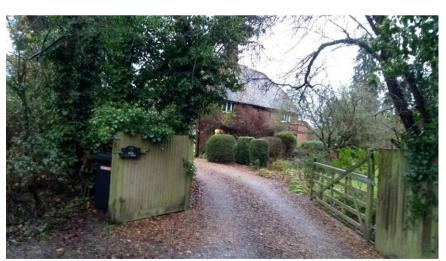
Figure 4 Kiln Cottage from south

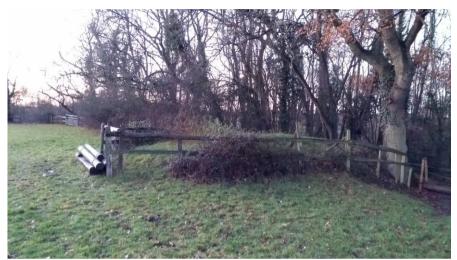
To the west of Hall Place Farm a mound exists partly in woodland and partly in the grass field (northern edge of Area 2 (Appendix 1 Figures 5 & 6)). It has been fenced all around. It is possible that this is some horse cross-country event feature, but it is also possible that its origin is more historic, perhaps for some industrial cause (windmill mound, slag heap, quarry spoil) or even more ancient as a burial mound (although it seems unlikely that this would not have been identified and entered on the HER previously).

Figure 5 mound Area 2 from east

The mound in Field 2 (Appendix 1 Plates 5-6) is of uncertain significance as it has not been included in the HER, its original function is not known, and it is undated. It could be of relatively modern origin. This would not be a constraint to development, but further assessment would be advisable if the land allocation process accepted the proposal of the Sulham land, so that any potential risk of archaeological significance can be discounted.

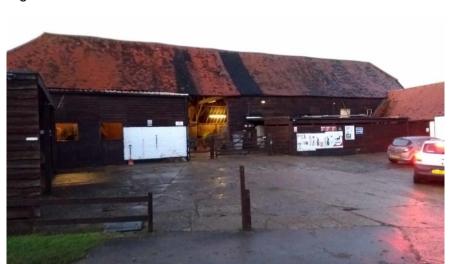
At Hall Place Farm, the farmhouse is a Grade II listed building, but there are also other structures of historic interest. Principally the great barn merits consideration as a heritage asset (Appendix 1 Figures 7 - 9), and to a lesser extent the other barns and workshops that group together as the historic farmstead. The site is likely to have been an ancient settlement focus, with medieval antecedents to the extant post-medieval form.

Figure 7 the great barn at hall Place Farm from south

The Hall Place Farm buildings (Appendix 1 Plates 7-9) are not listed, but their close relationship with the listed farmhouse and their evident age and design would indicate that they should be considered heritage assets which would merit protection due to their contribution to the setting of the listed building. In addition some or all of them could lie within the curtilage of the listed farmhouse, and could be interpreted as protected by the designation.

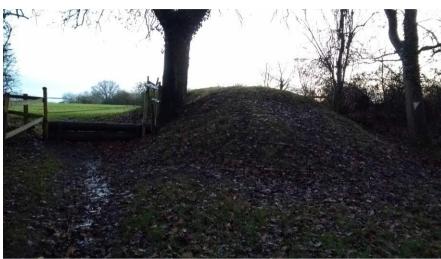
Figure 6 mound Area 2 from north

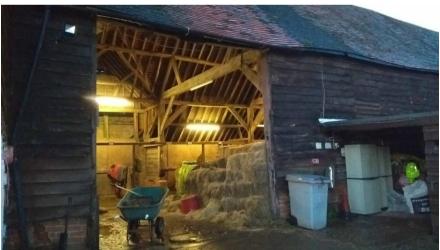
Figure 8 interior of the great barn showing timber construction

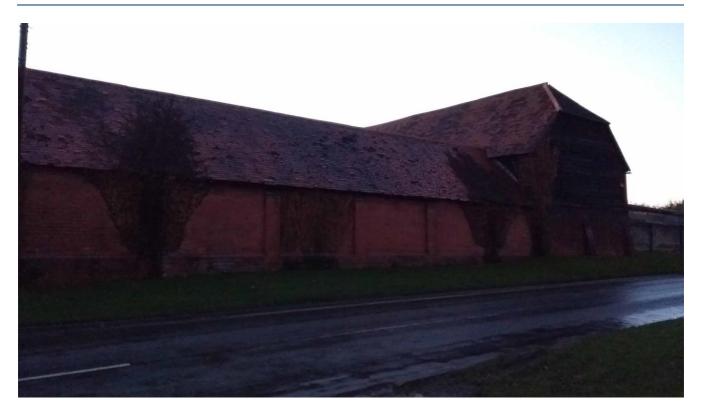
Figure 9 barns and roof of great barn at Hall Place Farm from east

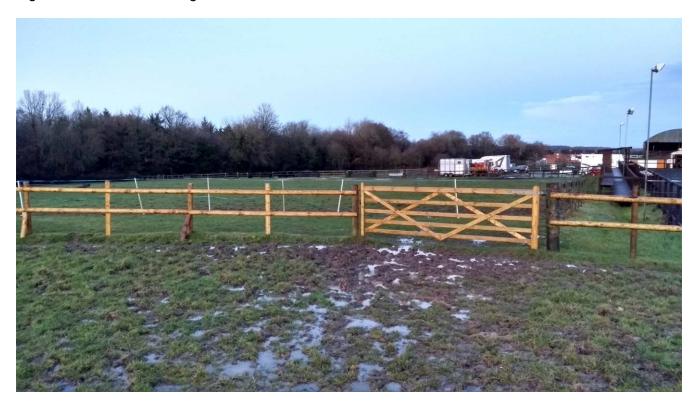
Figure 10 view of Area 1 showing clutter of vehicles, modern structures, high level lamps within the setting of the listed building at Hall Place Farm

Area	Heritage sensitivity and reasons
Hall Place Farm	High: immediate setting and proximity to Hall Place Farm LB
1	Low: no known assets, field eyesore at present & detracts from LB
2	Medium: field maintains farmland setting for Hall Place Farm; mound
